# 大型球铁飞轮的无冒口铸造

(镇江船用柴油机厂, 江苏 镇江 212011)

**摘要:**大型球铁飞轮曾因缩孔、缩松报废。业已查明, 缺陷是由于采用冷冒口工艺所致, 因为冷冒口实际上起排放冷铁液作用。取消冷冒口后, 缩孔、缩松问题成功地得到解决。

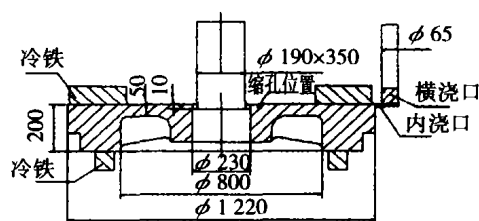
图 2 原工艺

此铸件采用呋喃树脂砂生产, 上下面采用外冷铁, 铁液由飞轮外圈顶面 12 道宽扁形内浇道进入型腔, 在内圈上面采用直径 190 mm 飞边冒口补缩, 冒口颈厚度 10 mm, 采用座包拔塞式浇注, 浇注温度控制在 1 300~1 350 ℃。原工艺见示意图 2。原工艺共浇注 5 件, 毛坯表面质量较好, 但经机加工后在受力螺栓孔部位有严重缩孔缩松缺陷, 缺陷部位如图 2 所示。

们对原工艺进行了分析, 认为产生缩孔缩松的原因是冒口补缩效果较差, 为了提高冒口的补缩作用, 决定在飞轮的内圈加放外冷铁, 加快下部的冷却速度, 进而提高冒口的补缩能力。按此工艺试生产了 2 件加工后, 在同样部位仍存在缩孔缩松缺陷, 只是缺陷程度有所减轻, 未能完全解决此问题。

(2) 为了彻底消除缩孔缩松缺陷, 我们再次进行了工艺改进。结合飞轮铸件结构特点, 我们认为此飞轮属于厚大球铁件, 而对于厚大球铁件, 在高铸型刚度、合理成分和浇注温度情况下可以实现无冒口铸造。在此基础上我们取消内圈上部补缩冒口, 对外圈外冷铁位置进行调整。按此工艺试浇了 3 件, 经加工后质量良好, 未发现缩孔缩松缺陷。
